Technical Report ARWEC-TR-99002

**METALLURGICAL FAILURE ANALYSIS OF THE M230  
MACHINE GUN BARREL – MIF-A-001-1999-I**

June 1999

U.S. ARMY ARMAMENT RESEARCH, DEVELOPMENT AND  
ENGINEERING CENTER

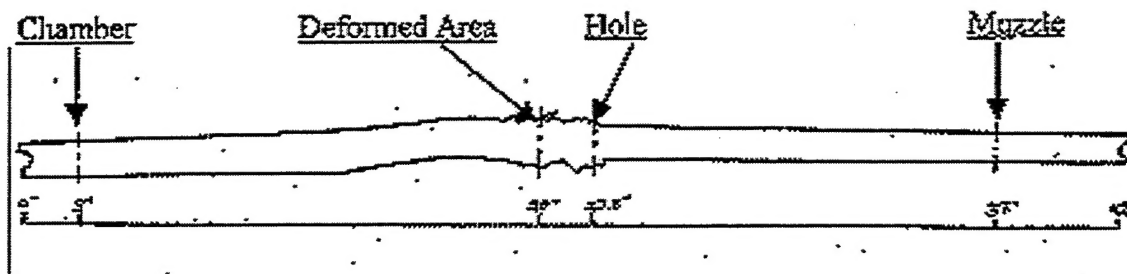
Figure 1  
Outline of the failed barrel showing where metallurgical specimens were taken from

One half of the longitudinally sectioned barrel was used for metallographic analyses while the other half was left intact. Sections of the barrel wall were cut, as shown in figure 1, then mounted and polished. Hardness measurements were performed using the diamond pyramid hardness (DPH) tester and then a semi-quantitative chemical analysis was performed on the specimens using energy dispersive spectroscopy (EDS). Finally, the samples were etched using nital to reveal the microstructures. Micrographs were taken of the microstructures using a light microscope/metallograph.

The microstructure and hardness in four areas of the barrel were examined to look for differences and changes to the original structure and hardness. The four areas analyzed were the muzzle end, through the large hole, a deformed area near the hole and the chamber end (fig. 1). Drawing no. 387-3116 calls out a maximum barrel hardness of 33 Rockwell C. Past work performed by the Failure Analysis Team at ARDEC has shown that the microstructure of the barrel is typically a tempered martensite (ref. 3).

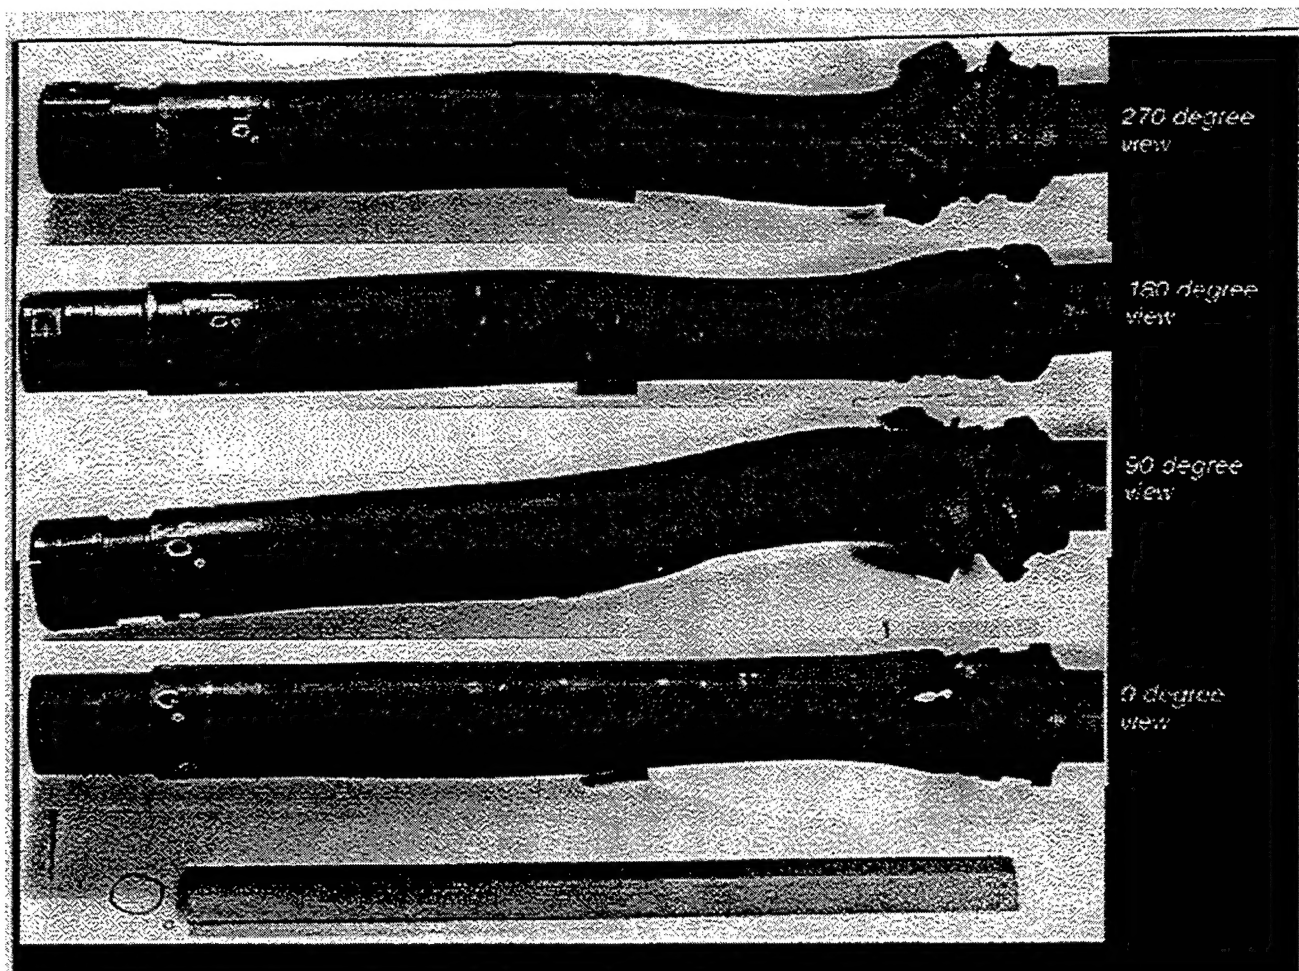
Figure 2  
Chamber-end of the barrel, 360 deg view

Figure 2 shows photographs of the barrel from the chamber end to just beyond the end of the remaining barrel support (or shroud). The barrel is severely deformed and there are two puncture holes that can be seen in the 0 deg view and the 180 deg view.

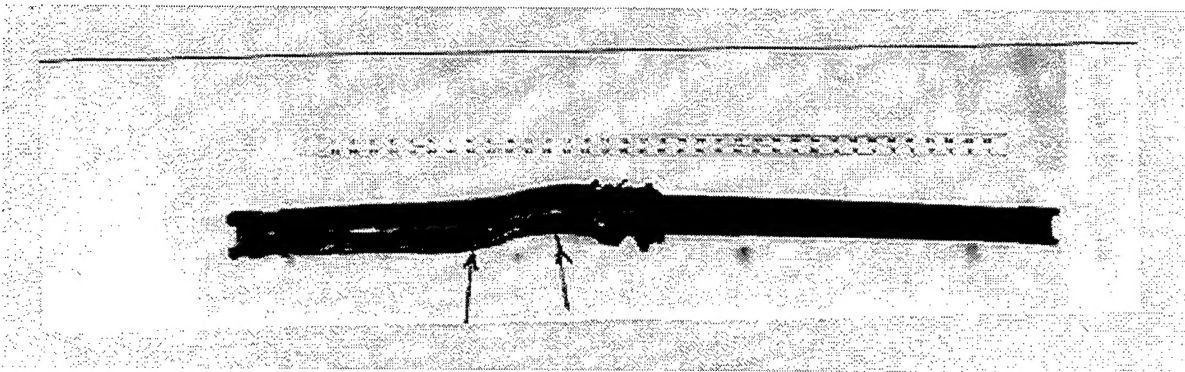
Figure 3  
Sectioned M230 barrel

A photograph of the barrel after it had been cut along its entire length is shown in figure 3. In addition to the lack of rifling between 8.5 to 21 in. from the chamber end, yielding and deformation of the barrel material was noted, see arrows. At 10.5 in. from the chamber, the wall thickness dropped down to 0.30 in. where it is normally about 0.50 in.

The fracture surfaces at the holes, where the projectiles exited, were examined. The fracture surfaces were pointed and the material was elongated nearly 100%. No brittle fracture surfaces or tensile dimples were noted. Tensile dimples are seen when a material exceeds its room temperature tensile strength. This suggests that the material did not fail due to a void or other manufacturing defect but rather from overheating, which caused it to lose most of its tensile strength yet increased its plasticity properties.

Arrows point to areas where the material has yielded.

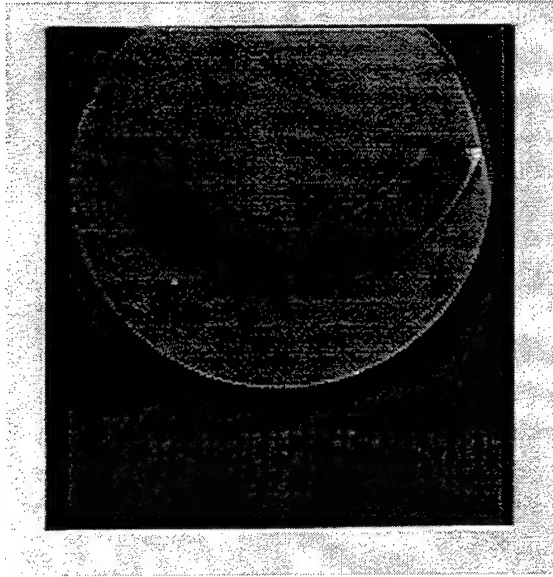
a  
Cross-section of the muzzle area

Figures 5a through d were taken from the muzzle region. Figure 5a is the cross-section view, while figures 5b through d are microstructures from different areas of the cross-section.

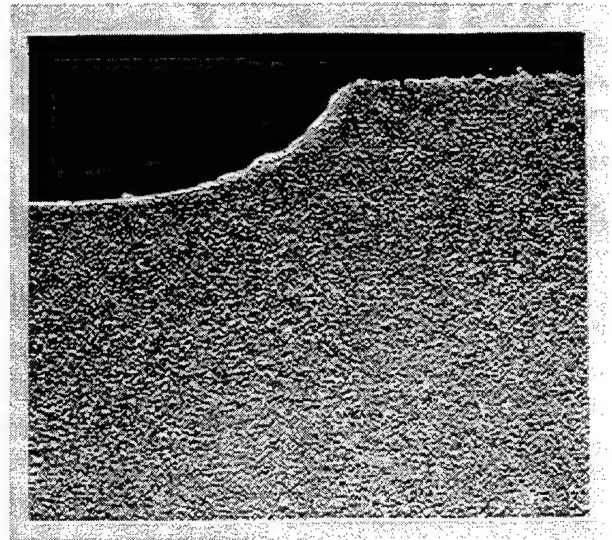
b  
Magnification, 42.6x

Figure 5b (50x mag., hardness 36 Rockwell C) was taken at a low magnification to show whether the microstructure in the lands and grooves had changed due to heat. No changes are seen. Figure 5c shows this same area at high magnification, 500x. This is a mixed microstructure and the hardness is a little high per the drawing.

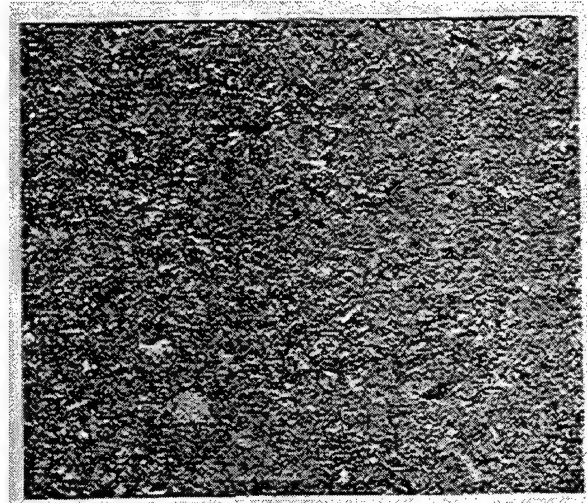
d  
Magnification, 426x

Figure 5d (500x mag., hardness 30 Rockwell C) is the microstructure from the mid-wall of the muzzle region. This is a tempered martensite structure which is typical for the M230 barrel. The hardness is appropriate per the drawing.

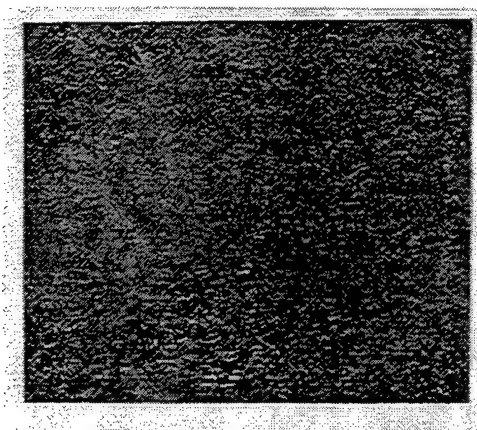
c  
Magnification, 350 x

Figure 6c (500x, 53 Rockwell C) is the microstructure of the bullet exit hole. This microstructure contains bainite and untempered martensite. The presence of bainite and untempered martensite coupled with an increase in hardness from 30 to 36 Rockwell C to 53 Rockwell C can only be accomplished by heating the steel above its austenitizing temperature (~1,400°F) and then quenching. Not all areas of the gun barrel wall achieved temperatures as high or higher than 1,400°F. Some areas on the outer diameter only got warm enough to be further tempered, such as the area in figure 6d.

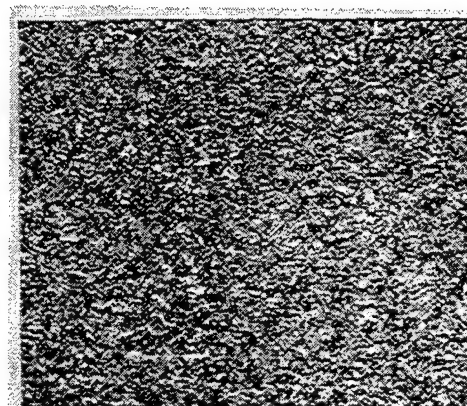
d  
Magnification, 350x

Figure 6d (500x, 27 Rockwell C) is a microstructure from the mid-wall. Compare it to figure 5d and contrast it to figure 6c. This structure is a coarse, tempered martensite. However, the hardness has dropped from 30 Rockwell C (as measured in the mid-wall of the muzzle) to 27 Rockwell C. For the hardness to drop as such, this area only got heated (or tempered) to about 1,200°F. This area did not go over the austenitizing temperature of 1,390°F and then get quenched.

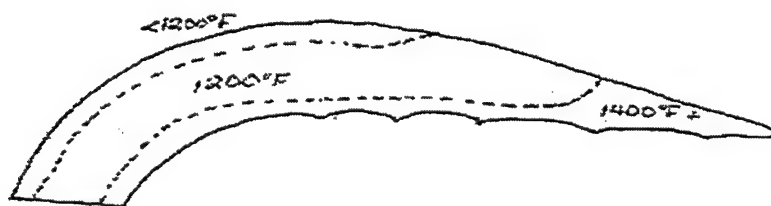
e  
Temperature profile of the cross-section of the hole region at the time of failure

Figure 6e shows the temperature profile of this area at the time of failure. At the exit hole and along the lands and grooves, the temperature exceeded 1,400°F. The mid-wall is shown reaching a temperature of 1,200°F while the outer diameter of the barrel stayed below a temperature of 1,200°F.

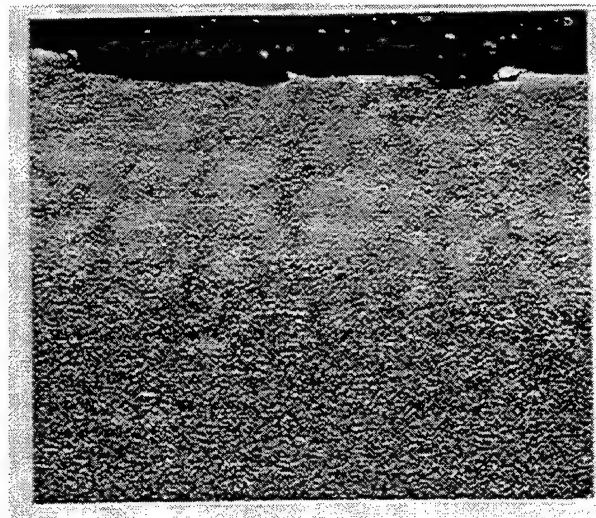
b  
Magnification, 42.6x

Figure 7b (50x, 54 Rockwell C) is a low magnification photograph of the lands and grooves area. The microstructure has changed due to heat in this area, as is evidenced by the presence of both the white and dark areas. Figure 7c is the same area at high magnification. Again, as in figure 6c where the hole was located, bainite and untempered martensite are observed. This area also, exceeded the austenitizing temperature and then was quenched in air to achieve this structure and hardness.

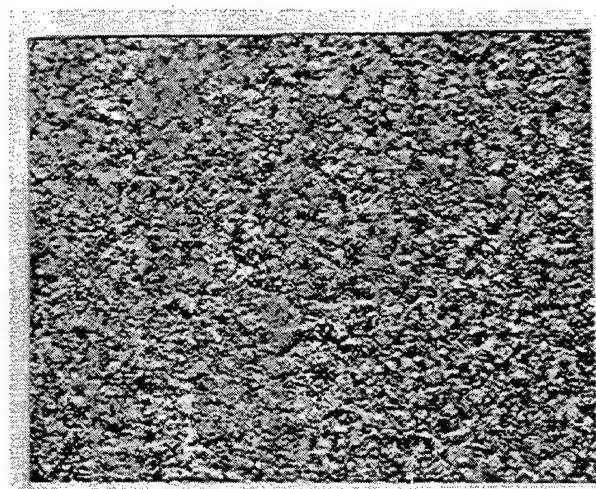
d  
Magnification, 426x

Figure 7d (500x, 34.5 Rockwell C) is the mid-wall area of the deformed area. This is a mixed microstructure and it is not clear what effect the heat had on this area.

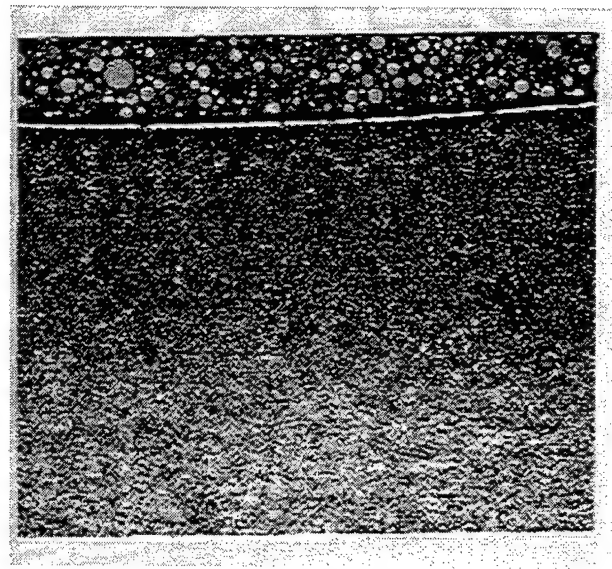
b  
Magnification, 42.6x

Figure 8b (50x, 40 Rockwell C) is the microstructure at low magnification showing no general changes to the microstructure due to overheating.

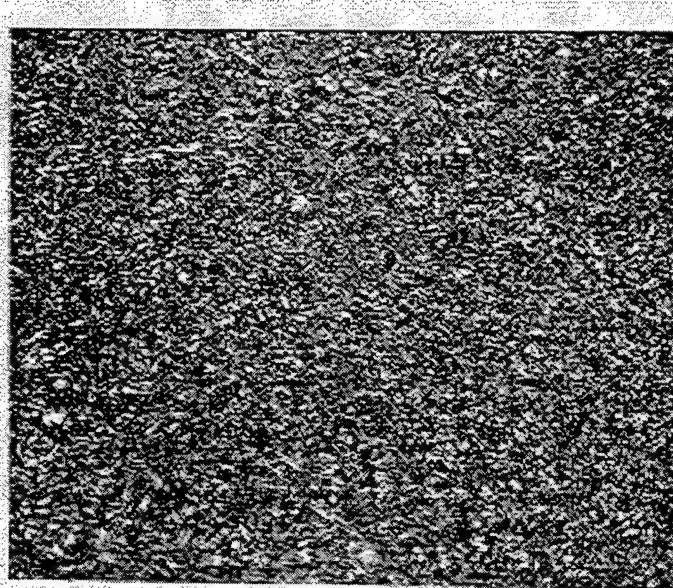
c  
Magnification, 500x

Figure 8c (500x, 33 Rockwell C) is the microstructure of the barrel mid-wall at the chamber end. This microstructure is fine tempered martensite. It is comparable to the microstructure seen in figure 5d from the mid-wall at the muzzle end. No changes in the microstructure due to overheating are seen. This is a proper microstructure and hardness for the D6-AC steel alloy used in the M230 gun barrel.

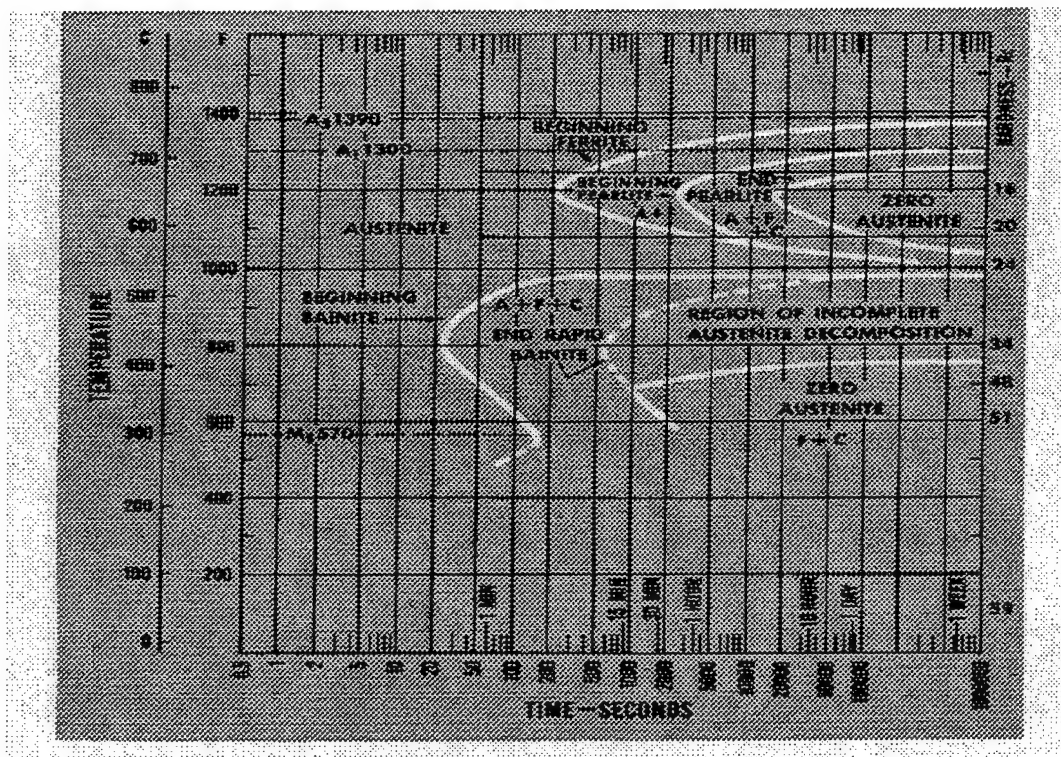
Figure 9  
Transformation temperature versus time for medium carbon alloy steels<sup>a</sup>

The change in the microstructures from tempered martensite to bainite and untempered martensite coupled with the increase in hardness values seen at the holes where the projectiles exited, supports the theory that the gun barrel steel exceeded the austenitizing temperature and then air cooled. A transformation temperature versus time (TTT) diagram is shown in figure 9. This diagram shows that the austenitizing temperature is 1390°F. The barrel may have gotten hotter than 1390°F, but with the various temperatures throughout the barrel and the subsequent variable quenching rates, it is difficult to pin down exactly how hot the barrel got in different areas.

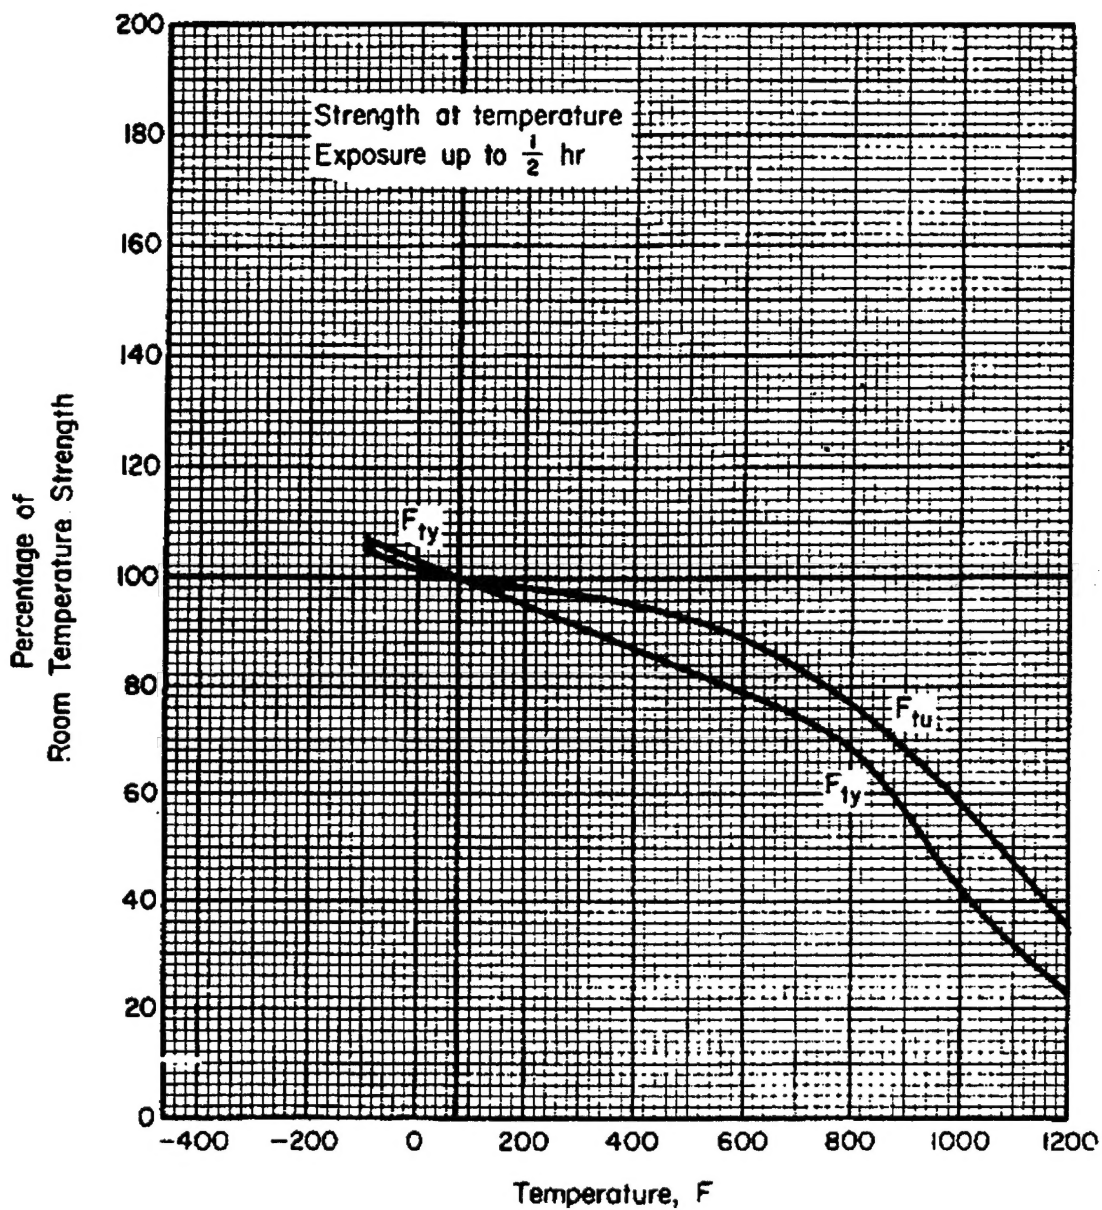
Figure 10  
Effect of temperature on the tensile ultimate strength ( $F_{tu}$ ) and tensile yield Strength ( $F_{ty}$ ) of AISI low-alloy steels (all products)

Once the barrel steel exceeds the austenitizing temperature, the hot tensile strength plummets (fig. 10). This diagram shows that at 1200°F, the barrel steel has only 35% of the room temperature ultimate tensile strength. Room temperature strength values are given in table 1. Thus, at 1,200°F the yield strength of the steel is 40 ksi maximum with the chances being that the yield strength is actually far lower than that at the austenitizing temperature of 1,390°F.
